Cat[®] Synthetic Rope Body Cable Manual

Cat[®] approved accessory for replacement of
OEM steel wire rope body cables

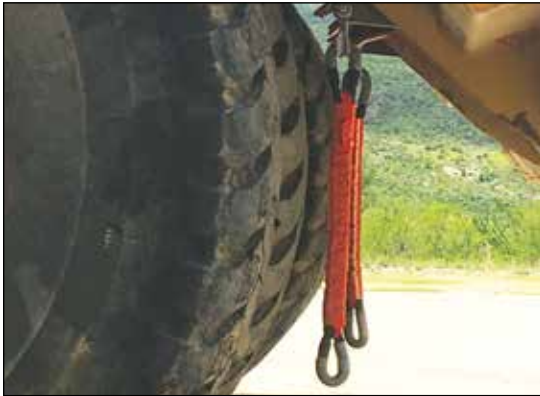
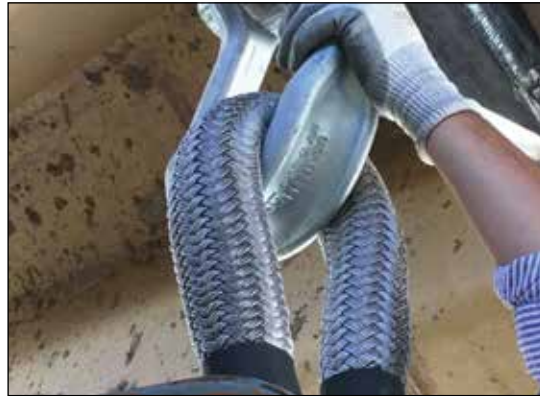
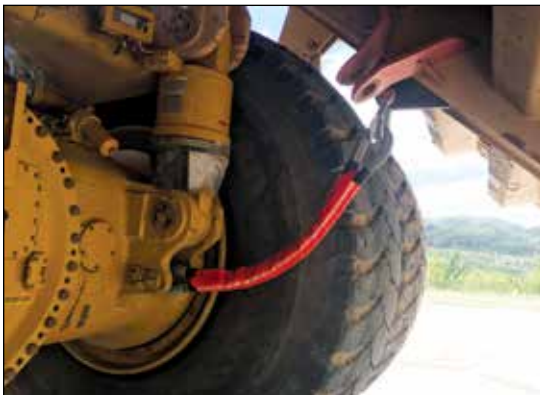
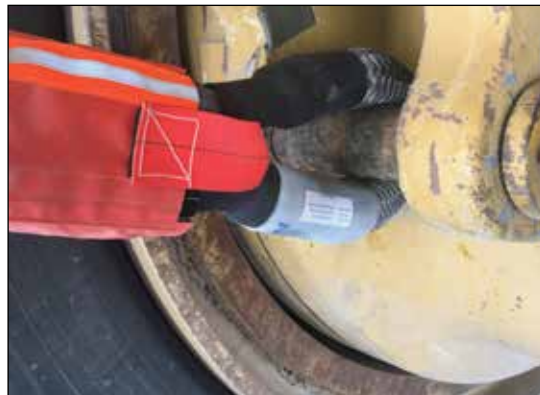
Installation Instructions

1. Use shackle for attachment to bottom underside of mining truck body for each cable.
 2. Other end of Synthetic Rope Body Cable is attached without shackle hardware to the truck body tow pin
- Note: The Synthetic Rope Body Cable should be stored in a protective bag or protected environment when not in use.

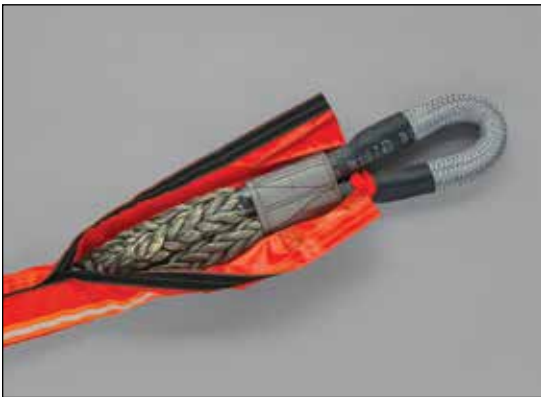
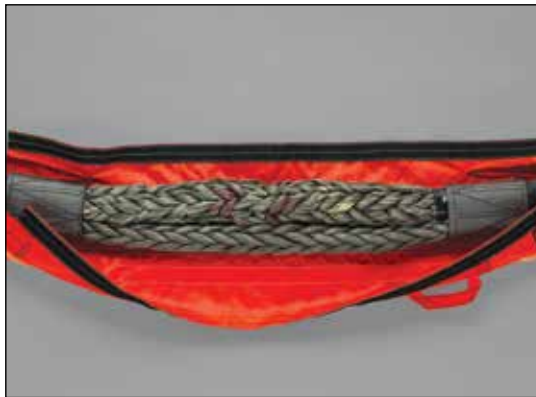
Step 3 Unfasten the body chafe sleeve to expose the inner strength member rope

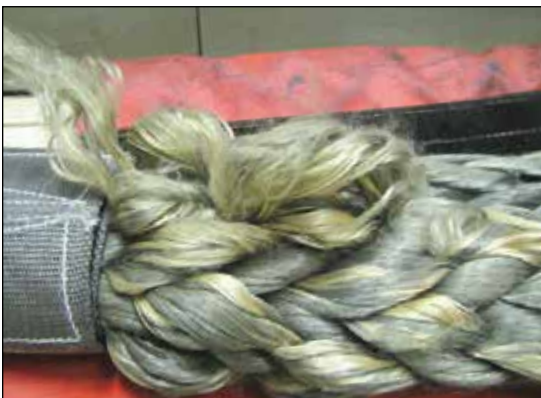
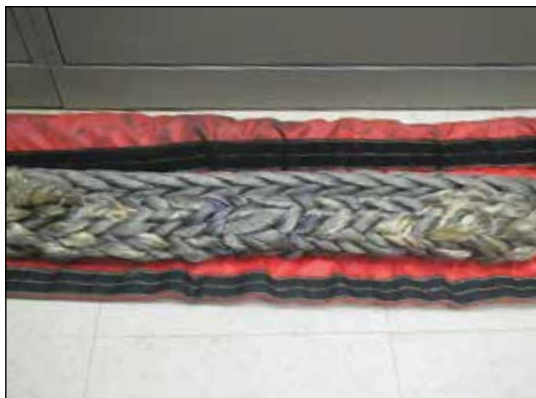
- “Loosening” or “undoing” of splice termination; strands which may be pulled out
- Cuts through one or more adjacent strands of the 12 strand braided rope strength member
- Excessive abrasion or cutting wear on the synthetic rope strength member

Each synthetic body cable is constructed using (12) primary “strands”. To splice-terminate the strength member assembly, the strands are interwoven back into the braided rope construction. These strand splices may become “un-tucked” from the braid if mishandled or dislodged by the hook-and-clasp body sleeve securement system. *If this occurs, the body cable must be removed from service and replaced.*

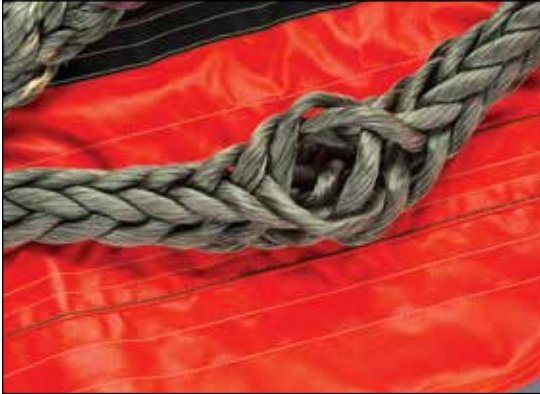
Step 5 Choose a short area of the braided rope length and, by compression, “open up” the braid to expose the inner hollow core of the rope. This inspection is to determine if there is inner abrasion or cutting wear caused typically by ingress of dirt or particulate.

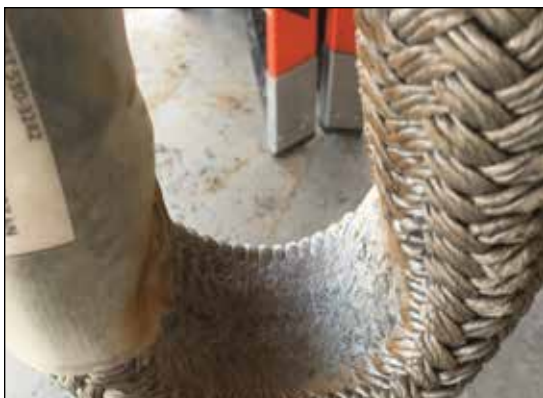
- Assuming that the Synthetic Rope Body Cable will not be left on the off highway vehicle during mining or construction work, thereby susceptible to excessive wear and cutting from the road environment, the Synthetic Rope Body Cable should really NOT see any wear abnormalities.
- The orange woven nylon body chafe sleeve is a replaceable item. The woven SX HMPE eye termination chafe gear is not replaceable.
 - In the SX HMPE chafe gear eye termination, the inner surface of the grey chafe sleeve may appear to be melted or heat-fused. Typically, this is simply fiber and braided rope construction compression and not melting. The method of inspection is compressing the area of concern to see if melting has occurred.

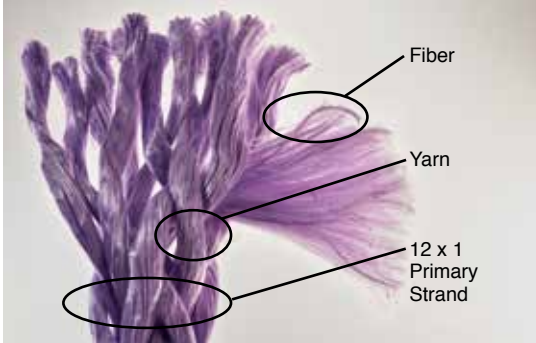
Repeated lateral abrasion wear against sharp edges is the primary cause of damage to braided synthetic ropes; i.e., cut yarns or strands. Partial cutting of yarns and/or strands can create an imbalance in load-sharing leading to significantly lower strength and body cable performance. **Visual and hand inspection for strand cuts is the key inspection method for these body cables; discard or retire if cuts in the rope are visible.**

The synthetic rope depicted in these (3) pictures are colored with a purple coating. While the construction of the body cable is the same as the pictures depicted here, the coating of the body cable is a grey/black color. The coating/color on the synthetic rope does not affect strength and may "lighten" as the rope gets older from use.

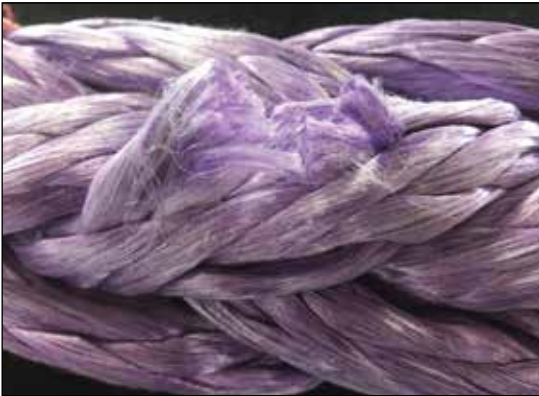
Visual inspection of interior yarns shows one partially cut yarn.

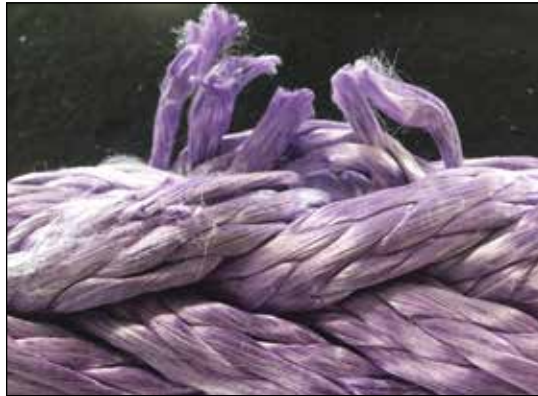
Visual inspection of interior yarns shows three fully cut yarns.
